Sailors and Marines Preventing Mishaps **BRAVO Zulu**

BZ
of the
Quarter

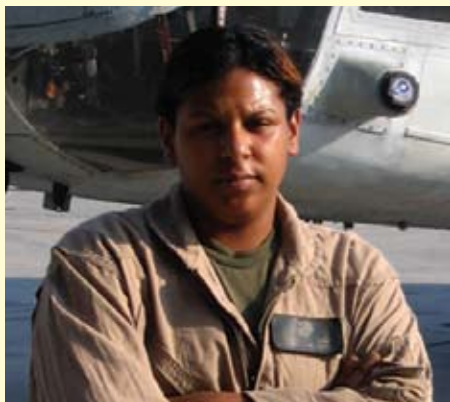
**Cpl. Sophia Reiser
HMM-365**

On a safe-for-flight inspection on a CH-46E, Cpl. Reiser noticed the lord mounts on the synchronization shaft were pushed too far forward. A closer look revealed the inner race for one of the synchronizing drive-shaft bearings was missing. She immediately notified a CDI and QA, who verified the inner race was missing.

An analyst at the Naval Safety Center said the missing inner race might have caused catastrophic failure of the synchronization shaft in flight, resulting in the loss of the aircraft and the lives of the crew.

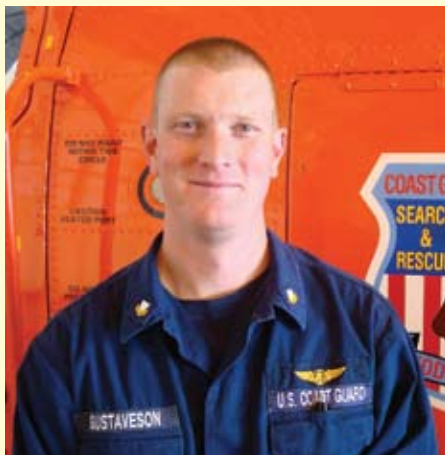
**AMT2 Michael
Gustaveson
CGAS Kodiak, Alaska**

During a recent search-and-rescue (SAR) case to Adak, Alaska, Petty Officer Gustaveson was doing a thru-flight inspection on a U.S. Coast Guard MH-60J helicopter CGNR 6035. He suddenly noticed the yellow main-rotor-blade damper was installed incorrectly.

Petty Officer Gustaveson's attention to detail prevented a premature failure of a dynamic component and prevented a potential aircraft mishap.

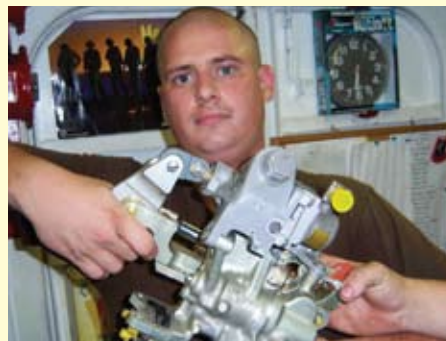
**AM2 Dustin Maxey
HSL-42**

Following a night of flying aboard USS *Vicksburg* (CG-69), Petty Officer Maxey found a cracked piston on the YAW boost-servo assembly of Proud Warrior 431. After discovering the problem on an early morning daily-and-turnaround inspection, he immediately notified his supervisor and maintenance control.

Petty Officer Maxey's keen attention to detail, quick action, and thorough knowledge of plane-captain procedures prevented a potentially catastrophic chain of events.

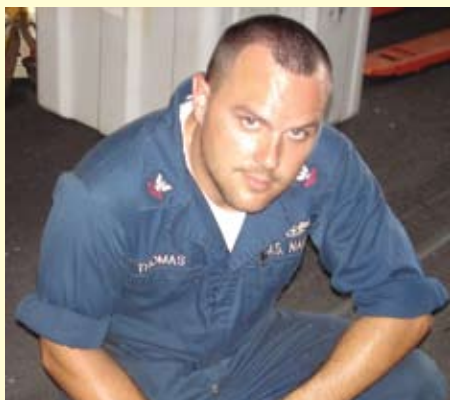
**AM2 Mark Thomas
HSL-44**

During a routine inspection of Magnum 446, Petty Officer Thomas noticed the sealant deteriorating on the No. 1 input module's mounting face to the main transmission. A closer look revealed that the input module was corroded severely at critical mounting points.

Had Petty Officer Thomas not found this problem, a catastrophic main-transmission failure would have been likely.

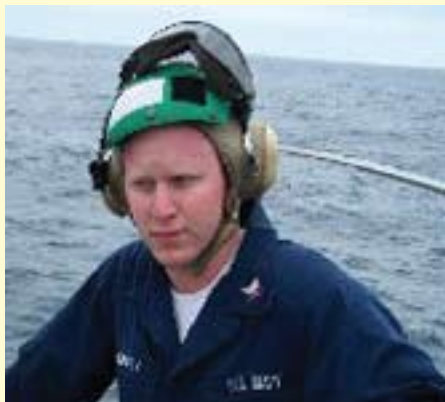
**AE2 Daniel Coffey
HSL-42 Det. 1**

During a routine weekly aircraft wash aboard USS *Klaking* (FFG-42), Petty Officer Coffey found a crack in one of the main-rotor blades of his detachment's only SH-60B. Ultimately, the cracked rotor blade was not safe for flight and could have resulted in catastrophic failure had it gone undetected.

Petty Officer Coffey's critical eye led to a timely repair, returning their sole aircraft to full mission-capable status.

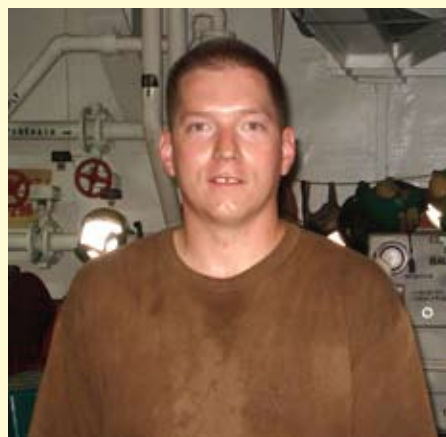
**AT2 Tyler Vidas
HSL-42**

On a routine FOD inspection on Proud Warrior 431, Petty Officer Vidas found a disconnected wire for the directional-control valve, which is used to position the fire bottles in the SH60-B's fire-extinguishing system. Had the aircraft been flown in this condition, the main and reserve fire bottles for all engines would have been inoperable in case of an emergency. His quick actions prevented further problems, and the gripe was fixed.

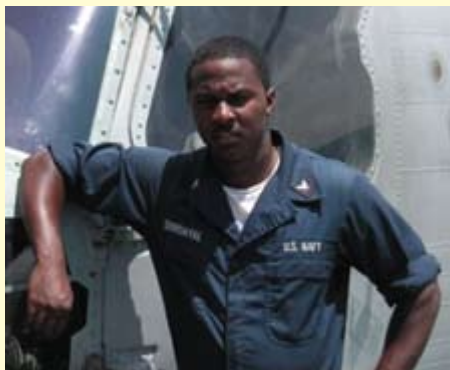
**AM3 Trevor Shivdayal
HSL-37 Det. 2**

Working on an SH-60B aboard USS *Chosin* (CG 65), Petty Officer Shivdayal located a pinhole leak in a hydraulic-pressure line for the No. 1 tail-rotor servo. Due to the awkward location and size of the hole, the leak would have gone unnoticed until the aircraft returned to flight.

Petty Officer Shivdayal's keen attention-to-detail and meticulous troubleshooting technique prevented a partial hydraulic-system failure and in-flight emergency.

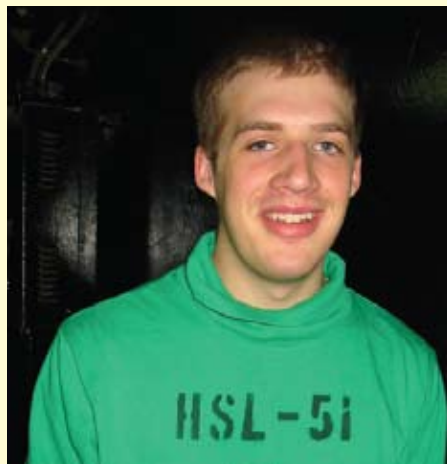
**AN Chad Helstrom
HSL-51**

While doing corrosion work on an SH-60B, Airman Helstrom found the hydraulic unions for the first- and second-stage tail-rotor servos were not seated fully. This vital assembly in the SH-60B controls the aircraft's heading through the tail rotor. Further inspection revealed that the jam nuts on the backside of the pylon had backed off. His good troubleshooting effort during a mundane task prevented a serious risk to flight safety.

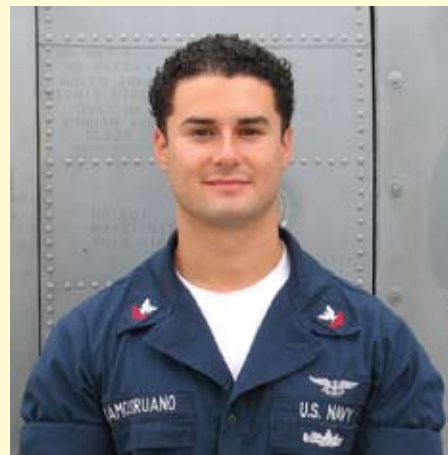
**A02 Alex Ramosruano
HSL-37**

During a plane captain preflight inspection of the engine compartment of an SH-60B, Petty Officer Ramosruano noticed a missing torque stripe on the B-nut for the load-demand-spindle (LDS) cable. A closer look at the B-nut showed the LDS cable was not secured correctly to the hydro-mechanical control unit (HMU).

Petty Officer Ramosruano immediately notified maintenance control and wrote a downing discrepancy. His ability to recognize and defuse a potentially dangerous situation prevented an in-flight emergency.

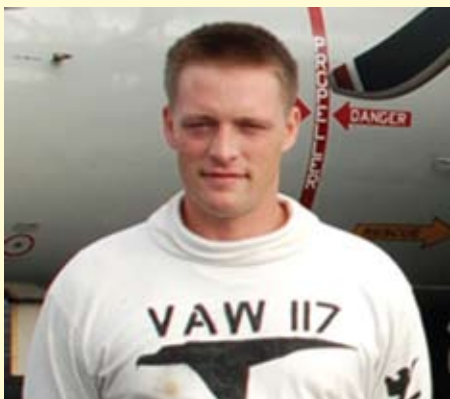
**AM2 Phillip Boykin
VAW-117**

Petty Officer Boykin was doing a high-power turn of aircraft 603 in the aft hummer hole aboard the USS *Nimitz* (CVN-68). During the start of the port engine, he felt the aircraft shift in an unexpected manner. The aircraft's wings had begun to spread unexpectedly. He quickly cycled the wing-spread lever from folded to spread and back to folded while taking the condition lever to ground stop. This action stopped the wings and caused them to re-fold, preventing damage to 603 and the surrounding aircraft and equipment.

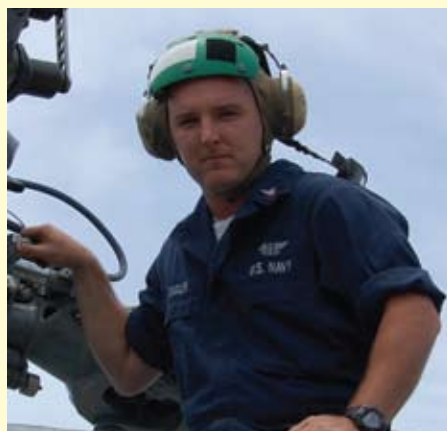
**AM2(AW) Philip Sadler
HSL-37 Det. 2**

During a 7/56-day inspection on an SH-60B aboard USS *Reuben James* (FFG-57), Petty Officer Sadler prevented a possible mishap when he noticed serious exfoliation corrosion on the hinge bracket of the APU door. Had it gone unnoticed, the hinge likely would have failed, causing the APU door to depart the aircraft. He immediately downed the aircraft and corrected the problem, returning the aircraft to flight status.

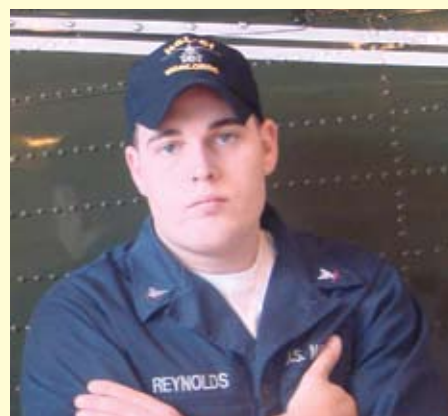
**AD3 Brian Reynolds
HSL-51**

Petty Officer Reynolds assisted on a 7/28-day special inspection on Walord 701. He found a 4-inch crack on the shear decking below the No. 2 engine intake and immediately reported it to a QA. The crack turned out to be a P&E repair. His keen eye and quick action prevented a possible flight mishap.

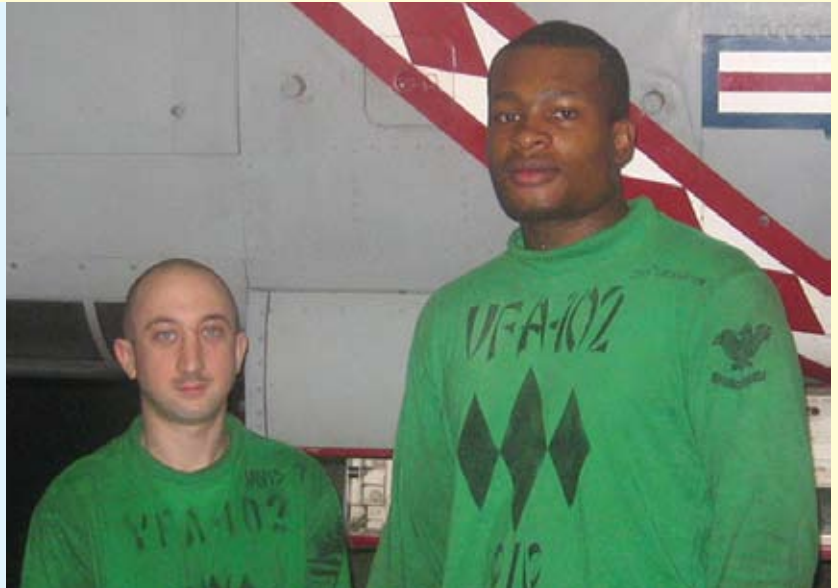
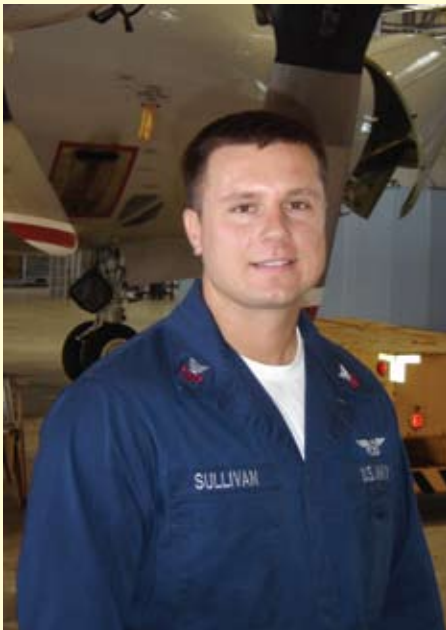
**AD2 Chris Davis and
AD3 Marvin Freshwater
VFA-102**

AD2 Chris Davis and AD3 Marvin Freshwater had been troubleshooting an over-fueling gripe on Diamondback 100 for days. After removing and replacing the wing high- and low-level pilot valves, fuel continued spilling out the vents. Undeterred, they suspected a failure of the high-level pilot valve in the No. 1 tank. When they opened that tank, they found the top of the fuel cell had collapsed. A closer look at the bladder cell showed several rub marks and damage beyond usable limits to the nylon barrier. They ultimately found a problem with the lacing was the culprit behind the collapse, revealing a flaw in the fuel cell and saving hundreds of man-hours in future troubleshooting.
